CMY-13R1-PCT

High Precision Cam Chain Tensioner Yamaha R1 (2009-2015)

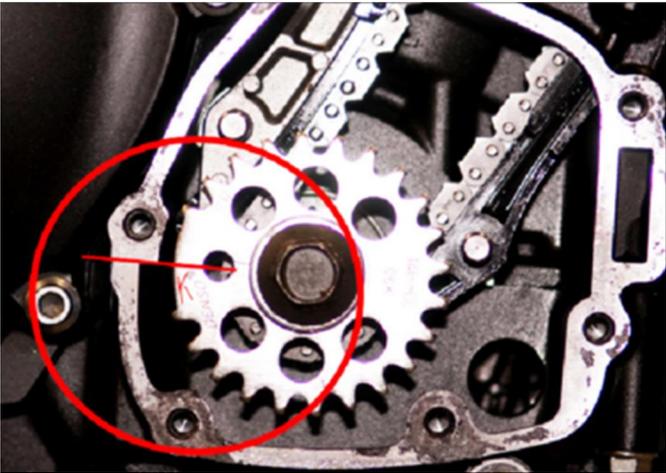
PHOTO 1

- 1) Remove the timing cover, aka pickup rotor cover, on the right side of the bike.
- 2) Rotate the timing sprocket, aka pickup rotor, in engine's normal rotation (clockwise) so the indexing line on the sprocket (marked with a K) is horizontally in line with the gap in the mating surface. **PHOTO 1**

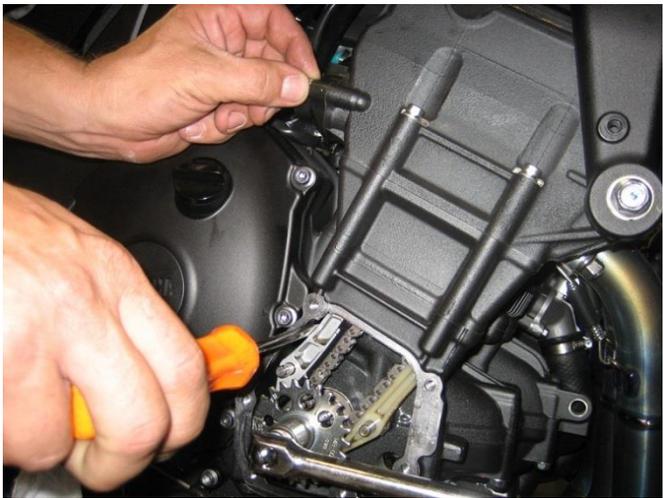
PHOTO 2

- 3) Remove the stock cam chain tensioner by first using a screw driver to place light pressure to the rear chain guide, being careful to not scratch any case surfaces **PHOTO 2**. Keep bolts for re-installation.
